Manhole Inspection Summary

Manhole # S07YY_011MH

Insp Date: **7/16/07 12:12 PM**

Location Address: **3402 CALLAWAY AVE**

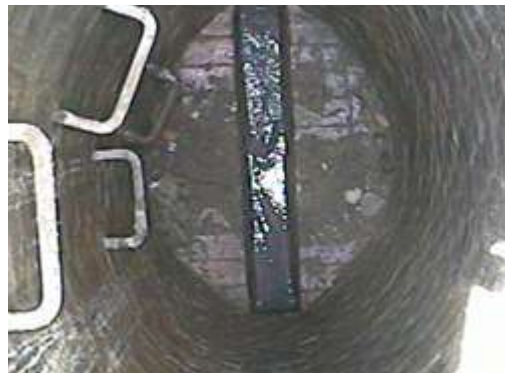
Top View

DEBRIS ON CHANNEL

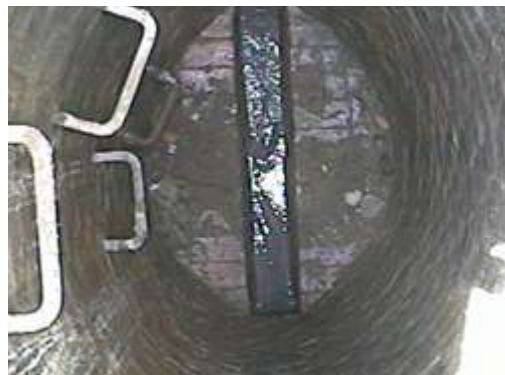
Defect 1

Steps Count: **6** Missing: **0** ☒ **Corroded**

CORRODED STEP

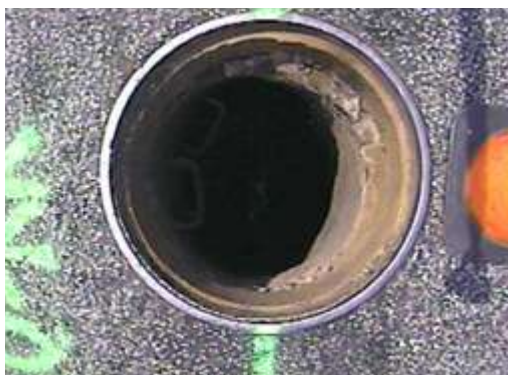
Defect 3

Frame Offset: **3** (in.) Condition: ☒ Sound ☐ Cracked ☐ Leaks

OFFSET FRAME

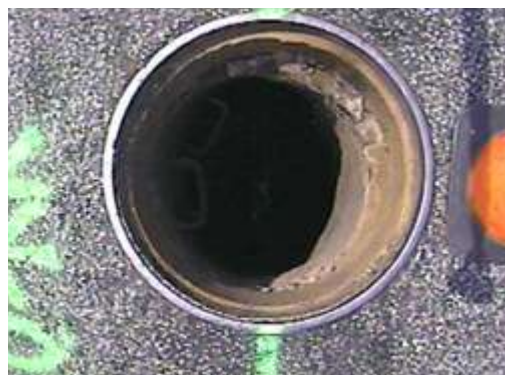
Defect 2

Condition: ☐ Sound ☐ Cracked ☐ Root Intrusion ☒ **Loose Brick** ☐ Deteriorated

LOOSE BRICK ON FRAME
ADJUSTMENT

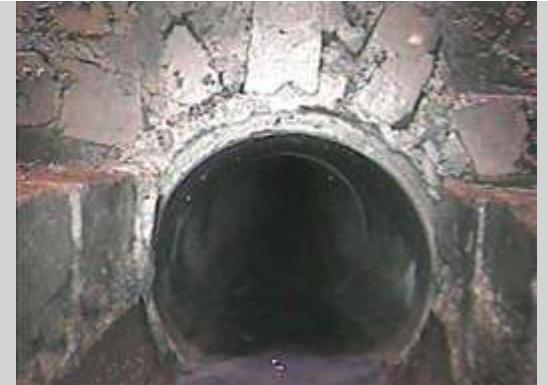
12 O'Clock Outflow

8 in. Circular Gravity Sewer
Pipe Out @ 12 O'Clock

Infiltration: **None** Pipe Seal Cond: **Cracked**

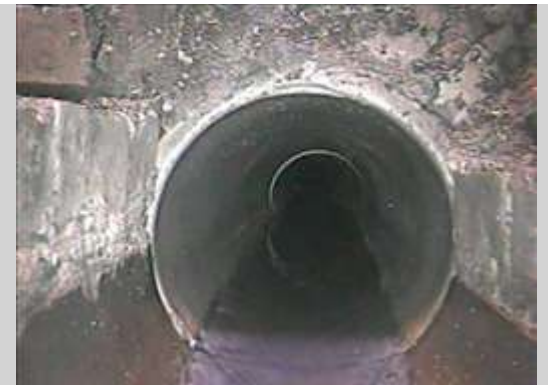
6 O'Clock Inflow

8 in. Circular Gravity Sewer
Pipe In @ 6 O'Clock
